**AGENDA TITLE:** Authorize the City Manager to approve removal of two (2) Eucalyptus trees and two (2) Maple trees at Lodi Lake

**LODI LAKE PARK  
TWO EUCALYPTUS TREES  
IN SOUTHWEST PARKING LOT**

PREPARED BY:  
CITY OF LODI - PARKS SUPERINTENDENT  
STEVE DUTRA, CERTIFIED ARBORIST WC-3311

**LODI LAKE - ARBORIST REPORT  
2 EUCALYPTUS IN SOUTHWEST PARKING LOT**

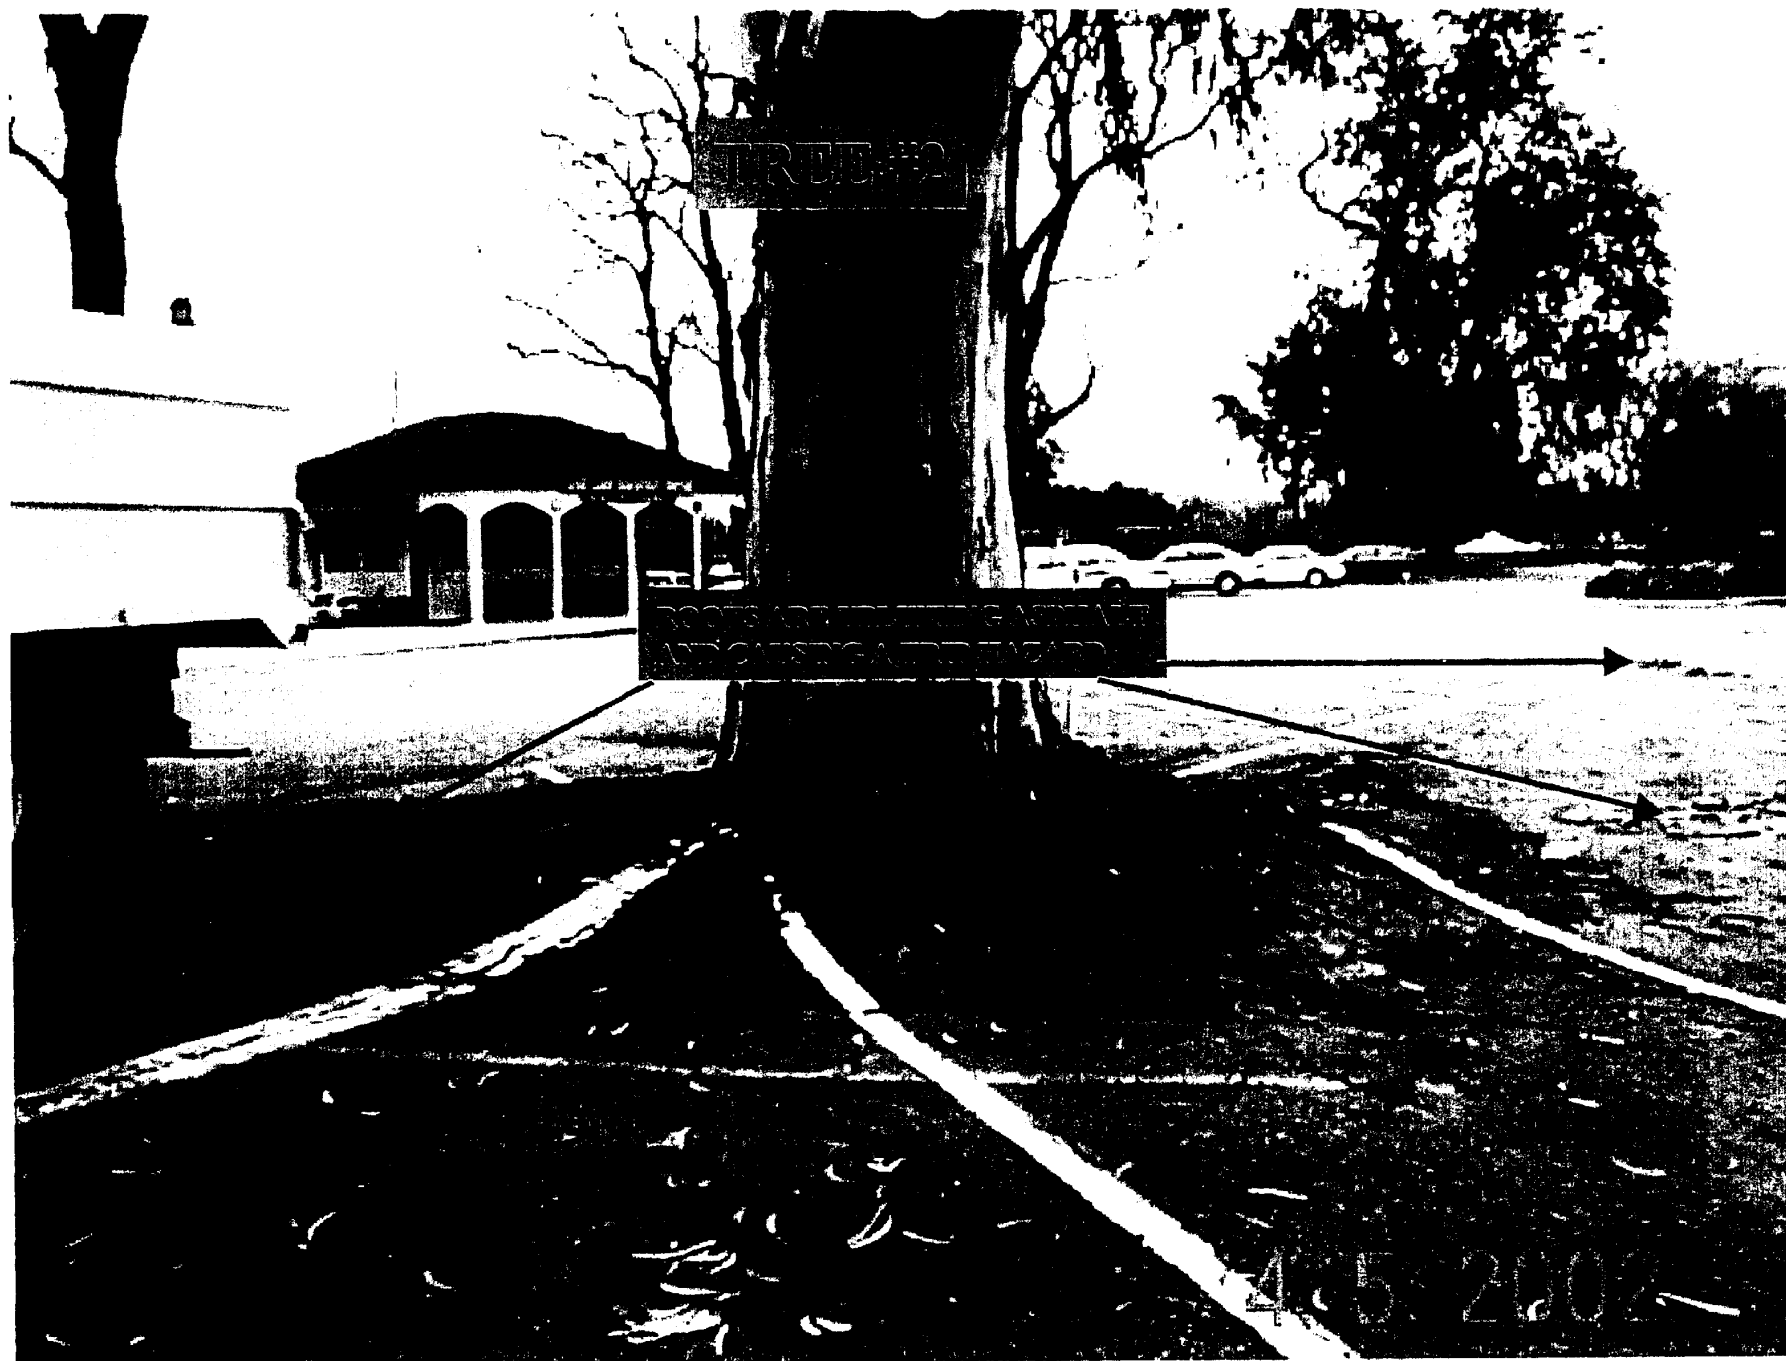
TREE #2

ROOTS ARE LIFTING ASPHALT  
AND CAUSING A TRIP HAZARD

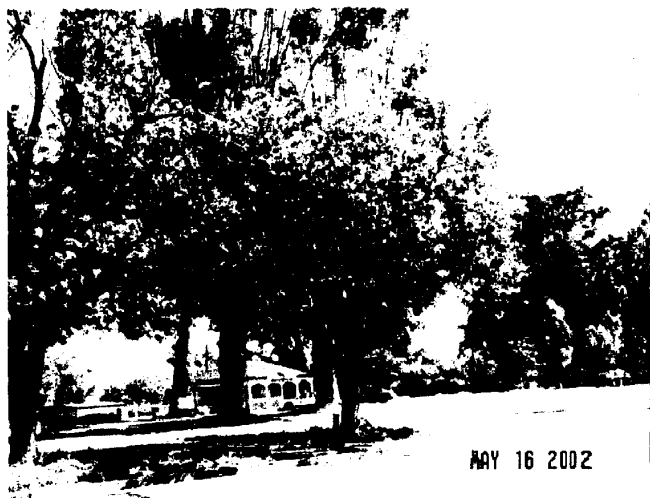
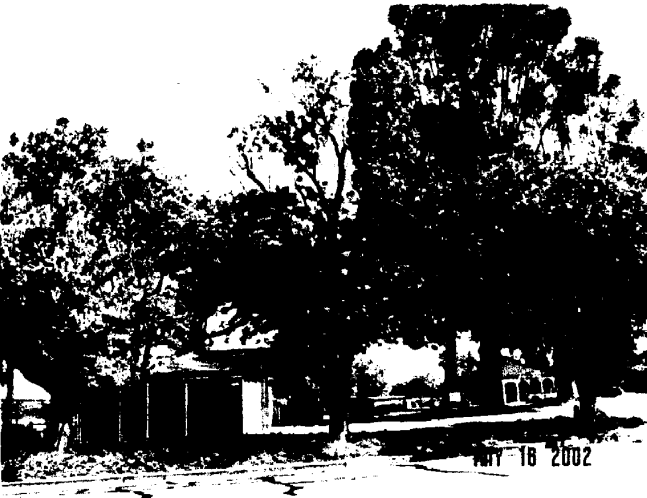
**PHOTOS OF EXISTING MAPLE TREES  
UNDER POWER LINES**

Additionally, staff is asking for permission to remove two Maple trees that are located in the planter bed under the electrical utility lines along Turner Road. The two Maple trees have been severely pruned over the years in an effort to keep them a minimum of ten feet from the lines overhead. Not only has the pruning been destructive to the trees, it increases maintenance cost for the utilities division. By giving us permission to remove the two Maples trees, we can then be allowed to select two trees that can grow to maturity but stay under the utility lines (The Right Tree In The Right Place).

Additionally pertaining to the parking lot project, I have contacted our Electrical Utility Department asking them to support the removal of two Maple trees located in the planter bed under the power lines along Turner Road (see photos). EUD will support the removal, including payment to a contractor for removal. Both of these trees are full of dead wood, decay and rot due to years of wanting to keep the trees ten feet below the power lines.

By removing both Maple trees and replanting with a smaller tree variety, keeping well below the power lines without requiring pruning two or three times a year, EUD will spend less annually on line clearance pruning.

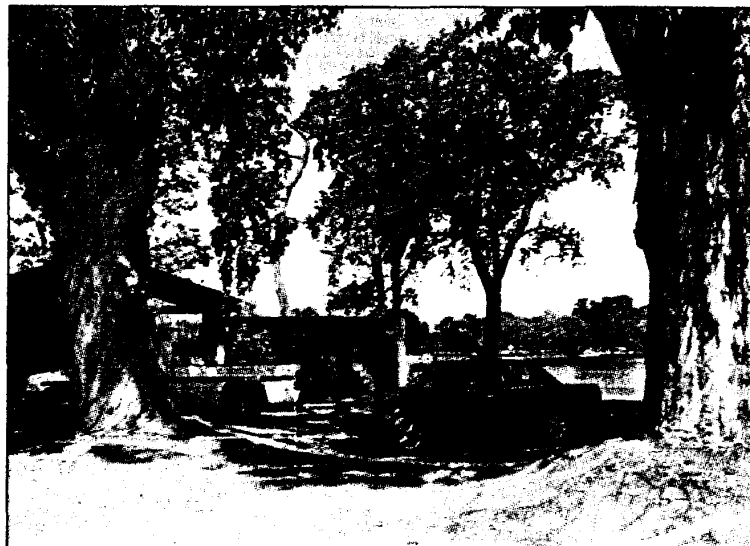
Two giant eucalyptus trees in the southwest parking lot of Lodi Lake Park may soon be cut down. The trees are reportedly diseased and have the potential of becoming a safety hazard.
